# E30 Water Leaks

Wet boot and damp dog smell getting you down? E30 water leaks are common but they're easy to solve.

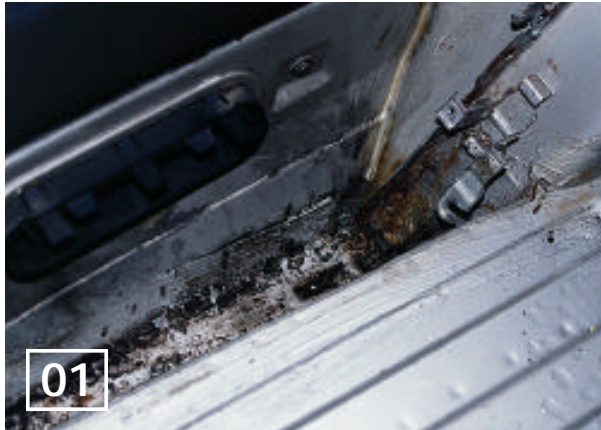
This is what you'll end up with if you don't catch it. Earlier cars had a small drain hole in these storage wells but later cars and the Touring did without this, so the water will accumulate and you'll end up with a large puddle and the beginnings of a rusty nightmare.

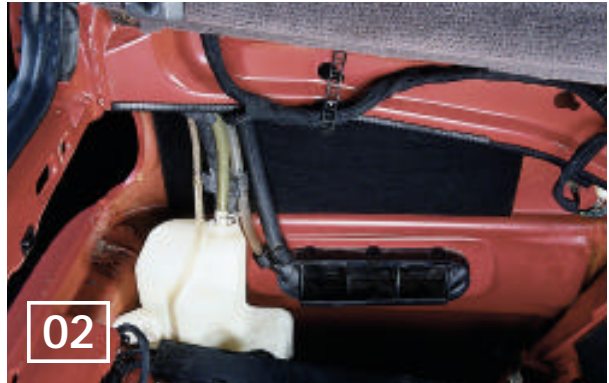
Before you rip the boot trim out, check the rear sunroof drain (the big black pipe) is draining properly out through the air extractor vent behind the bumper. Throw some water over the outside of this area and check the vent is sealed against the bodywork too. On the Touring you've also got the rear window washer reservoir in the boot, so check the bottle and the pipework isn't leaking.

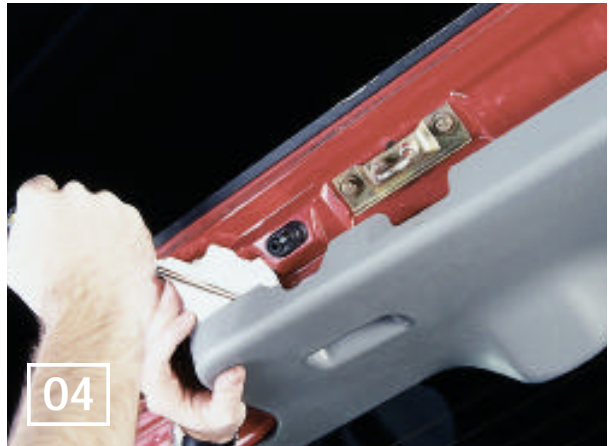
... in order to unclip the plastic trim around the window. The gas struts unclip after the retaining spring is flipped out with a screwdriver, then the rest of the trim just unclips. Use a long screwdriver and protect the paintwork with a cloth and you should find you don't break any of the clips.

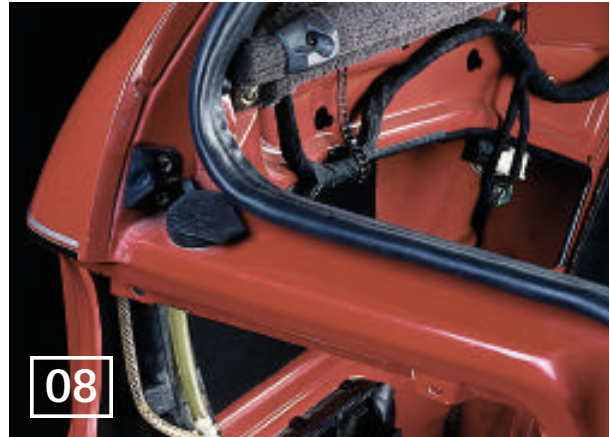
Clean up the bodywork where the lamp seal sits against the bodywork, as any grit here will affect the seal and it only needs a very small gap in the seal to cause a major leak.

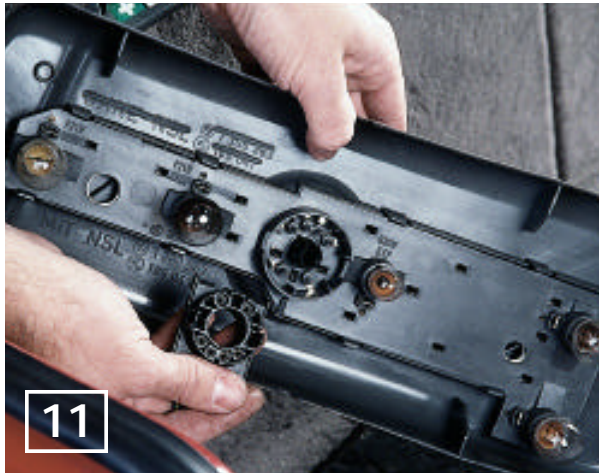
When you reconnect the electrical plug to the lamp unit, take the chance to clean up the terminals as a poor contact will have the lamp failure warning flashing on cars with the check panel.

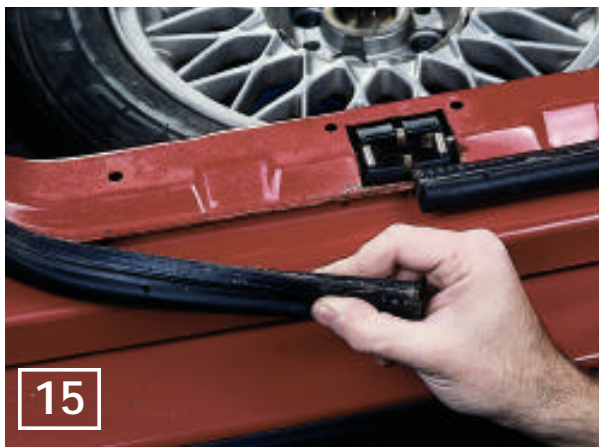
Simply pull the old seal away, clean up the bodywork flange underneath and then you're ready to fit the new seal.

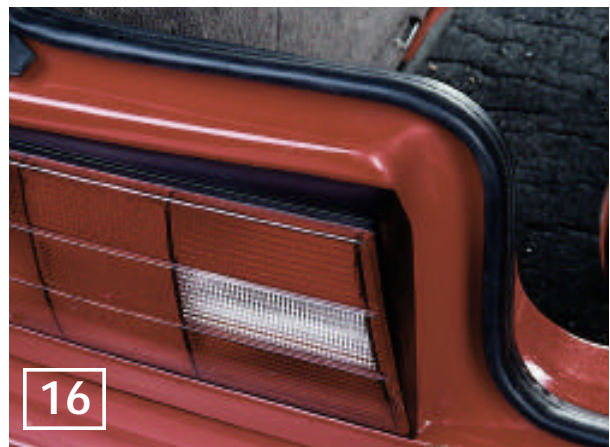
The new seal is just pushed on to the flange on the bodywork. Start at the centre under the boot lock and thump it with either your fist or a hammer and a piece of thick cardboard until it seats properly, especially around the tight corners.

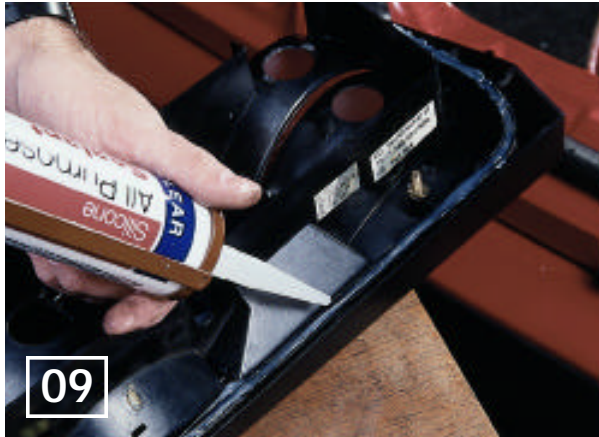
The old seal will be all flat and lifeless so simply pull it out of the lamp unit and clean up the channel where it fits. We chose to use silicone sealant to seal the new rubber in place but this is probably overkill.

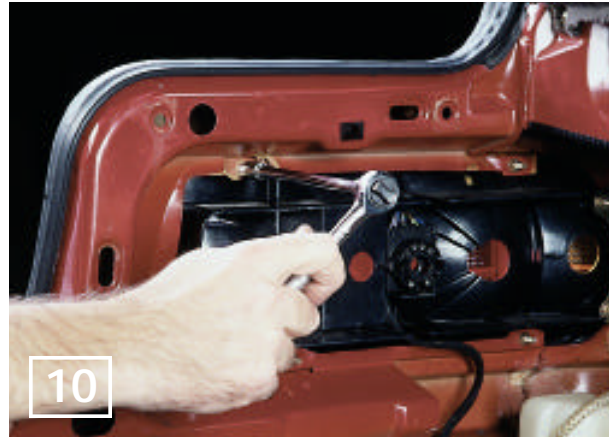
Replace the lamp unit, ensuring that the seal sits flat against the bodywork and tighten the nuts carefully in sequence, working round the lamp to seat it evenly against the bodywork. Make sure it's sealed properly but don't overtighten the nuts or you'll crack the plastic lamp unit.

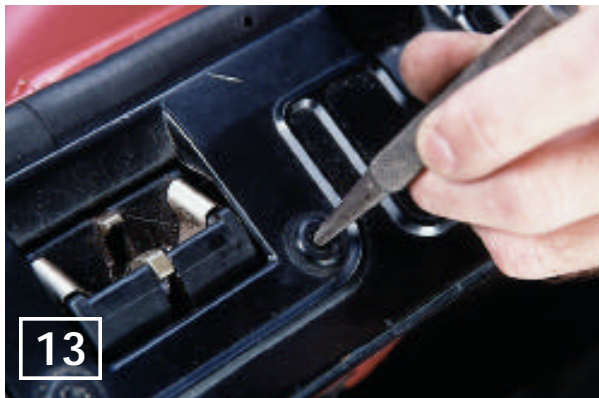
The seal just pulls off on the saloon but on the Touring you need to remove this plastic trim piece. It's held in place with four plastic fittings which use a centre pin to expand the teeth and hold them in place like a Rawlplug. They can be removed after the centre pin is knocked out with a punch and a hammer. Fish around in the hollow sections with a torch and if you're lucky enough you'll recover all the centre pins to use again.

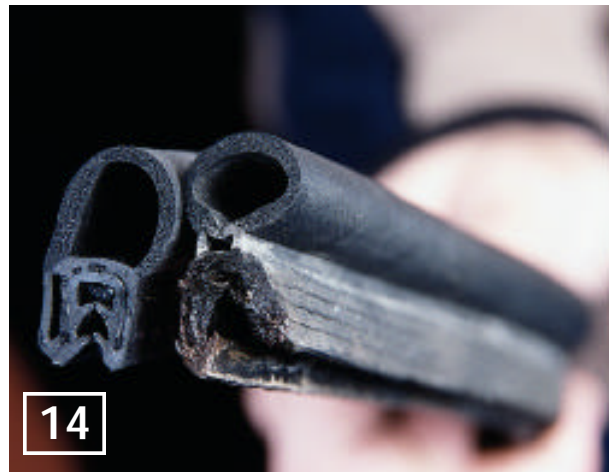
The new seal is £32 from BMW and if you compare it to the old one you'll see that the design has been slightly improved, with a bigger cross-section.

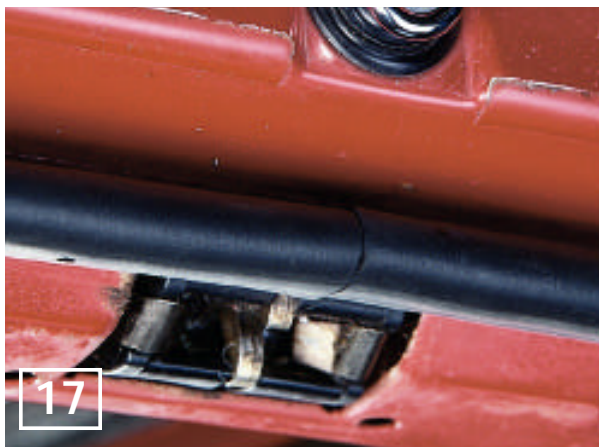
Make sure the ends meet. The new seal has an extra piece of rubber protruding from one end which will fit neatly inside the other end to seal it neatly without a gap.

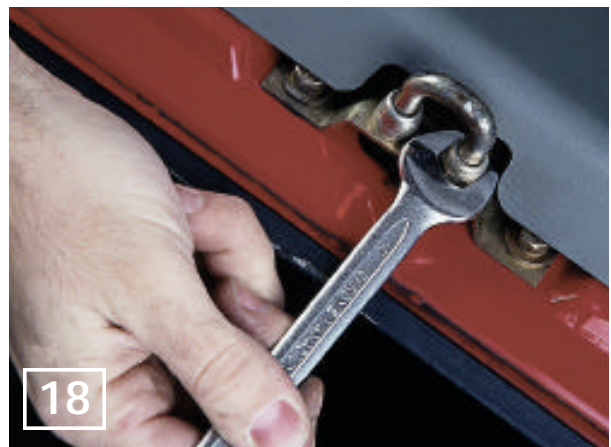
Adjust the boot lock until the boot shuts properly and you're finished. You want the boot to shut tightly against the seal and if it requires a firm push by the badge to latch it then that's about right. On the Touring you may also have to adjust the rubber buffers at each corner.
